Heavy Agricultural Loads on Pavements and Bridges

Sponsored by the
Iowa Department of Transportation and the
Iowa Highway Research Board

March 1999

Iowa DOT Project HR-1073

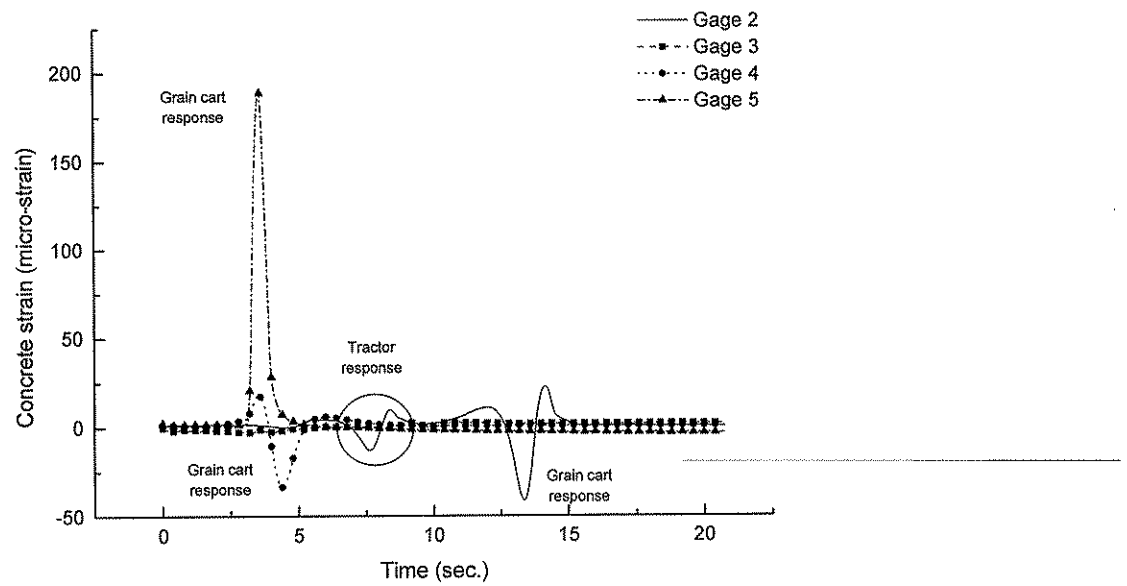
Calculated tensile stresses for Tests 1 and 27 were 900 and 1,161 psi (6,205 and 8,004 kPa), respectively, at the Gage 5 location, which exceeded the modulus of rupture of 657 psi noted above by 37% and 77%, respectively. As stated earlier, the five gage locations were determined prior to knowing all of the test variables, and it should be noted that the Gage 5 location was the closest of all of the gages to the position determined from the actual weight and tire pressure of the grain cart to be the highest strain location. As illustrated in Table 1, the median values for Gage 5 were the highest of all the gages.

Figure 6. Test 1 strain vs. time plot with cart traveling north to south (left to right)

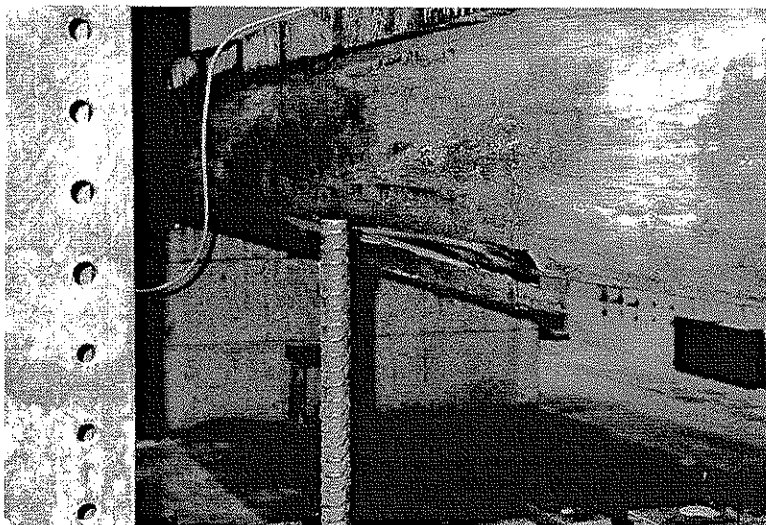
Figures 10 through 13 show splits that took place in some stringers resulting in the failure of the bridge. Note that stringers 1N, 2IN, 3M, and 4IS all exhibited major splits at failure. From the data plot, it appears that stringer 3M failed first and the splitting was most likely initiated by a flaw in the bottom tension fibers near mid-span. Stringer 1N failed next, followed closely by stringers 2IN and 4IS. A visual inspection of the sill plates showed no noticeable crushing of the wood under the stringers. Inspection of the deck planks also indicated that there was no noticeable damage. Failure of the bridge was sudden and was characterized by flexural failure of the stringers.

Figure 10. Stringer 1N failure - Bridge 1.

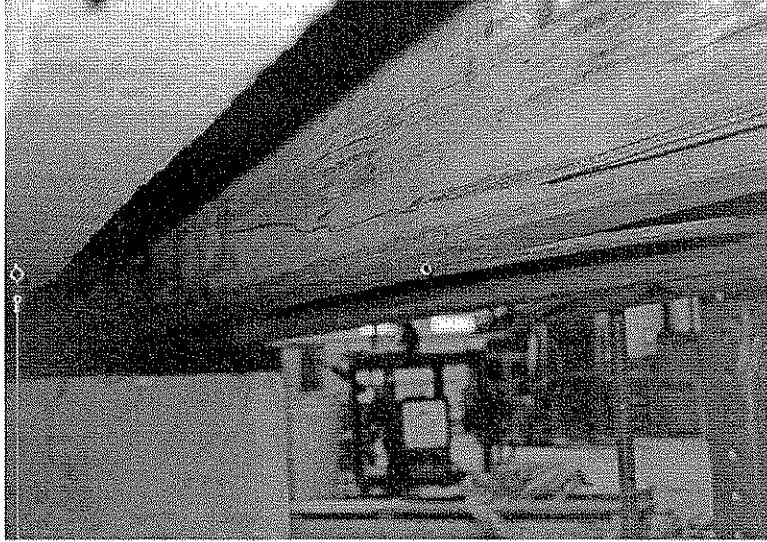
Figure 11. Stringer 2IN failure - Bridge 1.

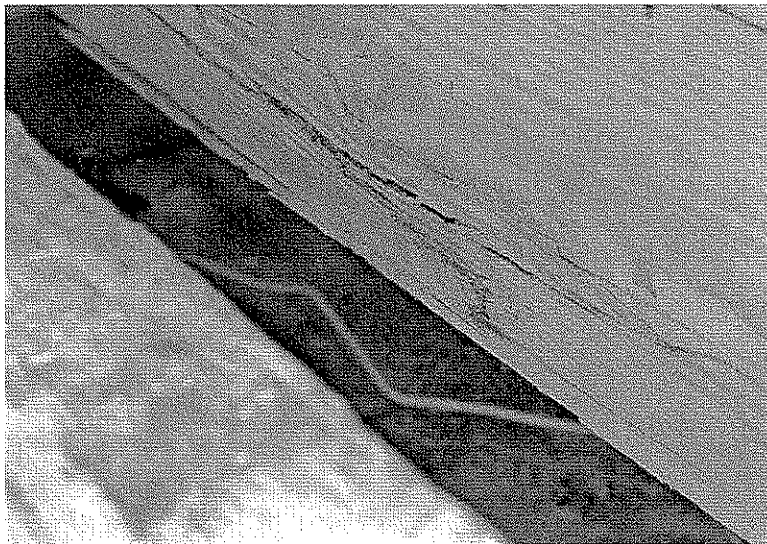
Figure 12. Stringer 3M failure - Bridge 1.

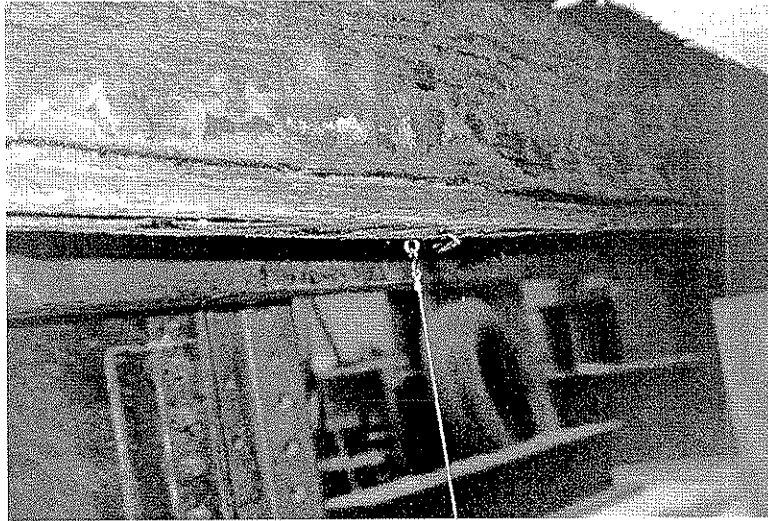
Figure 13. Stringer 4IS failure - Bridge 1.

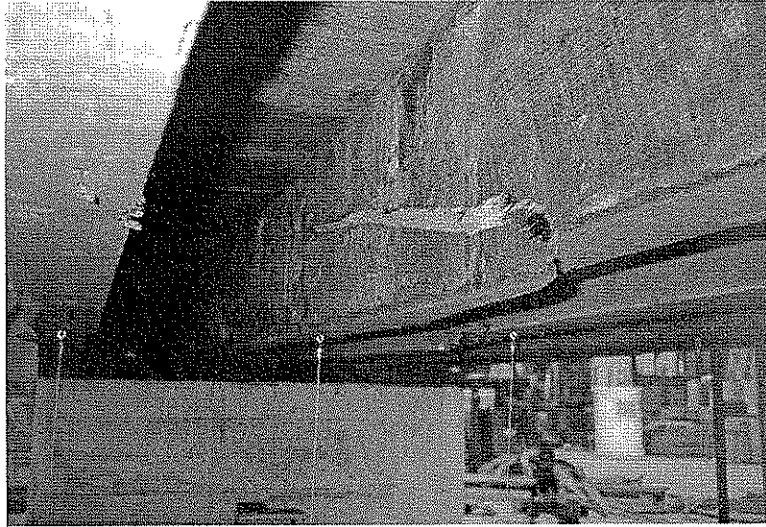
Based only on the observation data mentioned above, it was noted that the first major crack occurred in stringer 4IS at a load of 28,000 lbs. (124.6 kN). Up to that load it was observed that the load/deflection plot was linear with the pairs of symmetrically loaded stringers behaving as in the Bridge 1 test. The two interior stringers (2IN and 4IS) had slightly less load/deflection slopes, indicating they were carrying a larger load compared with the outside stringers. The middle stringer (3M) deflected the most, indicating that it was carrying most of the load. From about 3,000 lbs. to 10,000 lbs. (13.3 to 44.5 kN), typical sounds described as popping and cracking due to the straining of the bridge and bridge stringers occurred. At 18,800 lbs. (83.6 kN), the sounds became more pronounced and distinct, indicating that significant cracking or fiber straining was beginning to occur. At this point, it was observed on the DAS monitor that stringer 4IS was deflecting more than stringer 2IN. At 28,000 lbs. (124.6 kN), a significant crack occurred in stringer 4IS. It appeared that the crack was initiated at a knot in the tension face of the stringer

(Figure 16). From 28,000 lbs. to 35,000 lbs. (124.6 to 155.7 kN), it was observed visually that the crack in stringer 4IS continued to open wider and additional cracking sounds, or fiber straining, could be heard coming from other stringers. At 39,000 lbs. (173.5 kN), the applied load dropped to 35,000 lbs. (155.7 kN) due to a failure in stringer 5S. It was also noticed that string 3M, the middle stringer, had developed a crack. It is believed that this crack occurred after stringer 4IS failed and before the failure of stringer 5S. Again, this crack seems to have been initiated by a knot in the wood close to the stringer tension face (see Figure 17). Additional loading back up to 39,000 lbs. (173.5 kN) resulted in horizontal cracking in stringer 5S (see Figure 18). The real time plot observed on the DAS monitor for the test at this point showed that the stringer mid-span deflections ranged from the smallest in stringer 1N to the largest in stringer 5S. This suggests that the final failure would occur in stringers 4IS or 5S. The ultimate load for the bridge was 40,100 lbs. (178.4 kN). Stringer 5S incurred considerable flexural cracking (see Figure 18). Stringers 1N and 2IN did not show any signs of distress or damage. The deck planks did not show any load distress. Failure of the bridge was sudden and characterized by the flexural failure of the stringers.

Figure 16. Stringer 4IS failure initiated in the vicinity of a knot - Bridge 2.

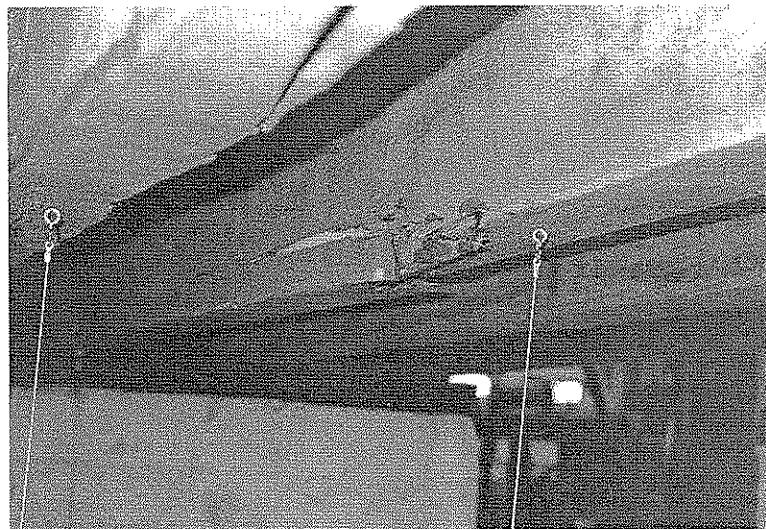
Figure 17. Stringer 3M failure at knot location in tension face - Bridge 2.

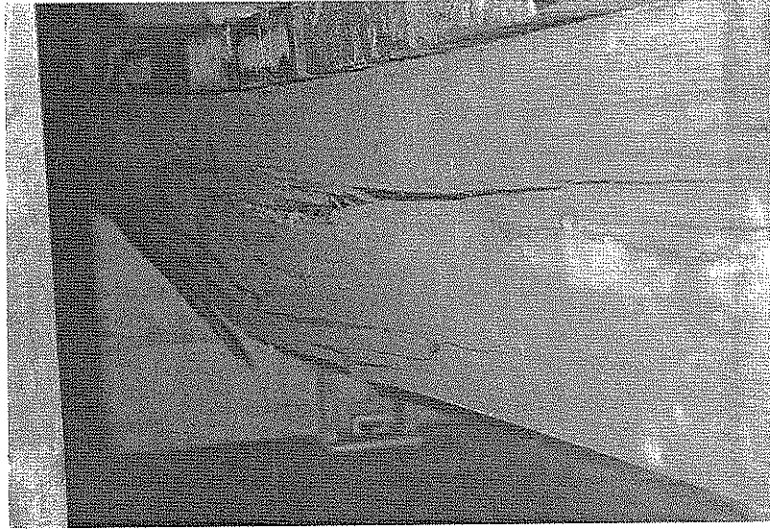
Figure 18. Stringer 5S failure - Bridge 2.

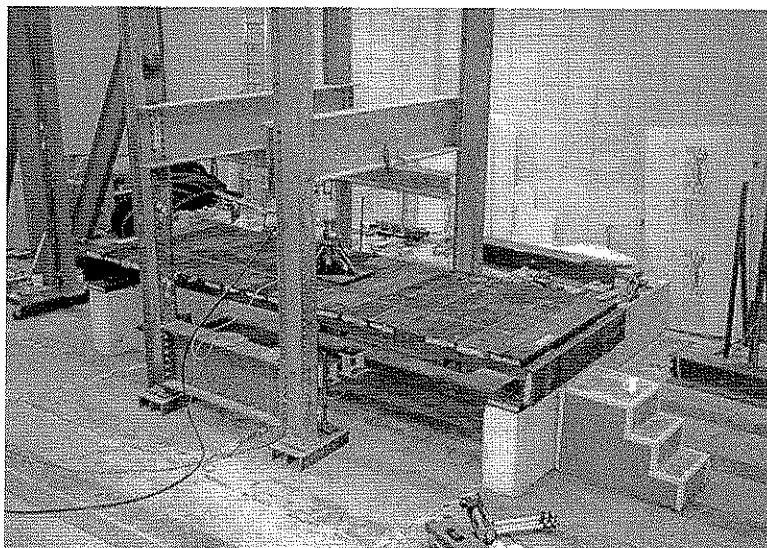
Noteworthy visual observations prior to testing included some splintering from weathering at the tension face (bottom) of stringer 1S at mid-span. In addition, the middle stringer (2M) had a minor split at the east support that appeared to run the full length of the stringer at about mid-depth. There also appeared to be some warping or twisting of stringer 2M at the west end.

Figure 20. Bridge 3 prior to testing.

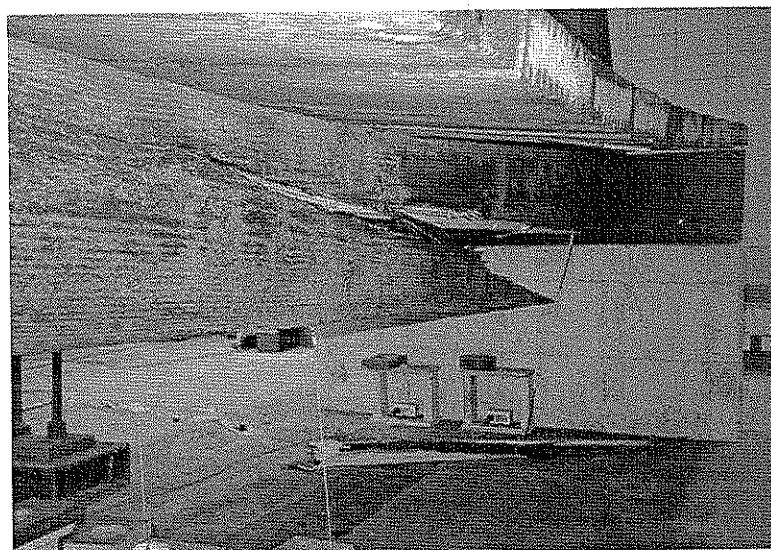
Figure 21 shows the load/deflection plot for the test. At a load of 3,000 to 5,000 lbs. (13.3 to 22.2 kN) noticeable bridge and/or fiber straining noises occurred. At 18,000 lbs. (80.1 kN), sounds of cracking could be heard and small clouds of dust could be seen coming off the bottom of the stringers. Referring to the plot, it appears as if stringer 2M, which contained the horizontal split, deflected less than stringer 3S but more than stringer 1N. At 23,000 lbs. (102.3 kN), the bottom of stringer 2M split significantly, resulting in a drop in the load of 1,000 lbs. (4.4 kN), and the deflection became greater than that of stringer 3S. Further loading resulted in an ultimate load of 27,200 lbs. (121 kN). At this point, stringer 3S suddenly failed near mid-span. Visual observation indicated that the failure initiated at a knot. A large piece at the east end of stringer 3S broke off and fell to the floor (see Figure 22). The split in the bottom of stringer 2M opened up considerably. There was no major damage noted to stringer 1N (see Figure 23). From the plot it appears that stringer 2M failed first and the sudden additional load to stringer 3S caused its failure. This may be supported by the fact that the load/deflection plots of these two stringers cross on Figure 21. The overall result of the bridge failure can be seen in Figure 24. Inspection of the deck planks indicated that there was no noticeable damage. Failure of the bridge was sudden and characterized by flexural failure of the stringers.

Figure 22. Stringer 3S failure (note piece on floor) - Bridge 3.

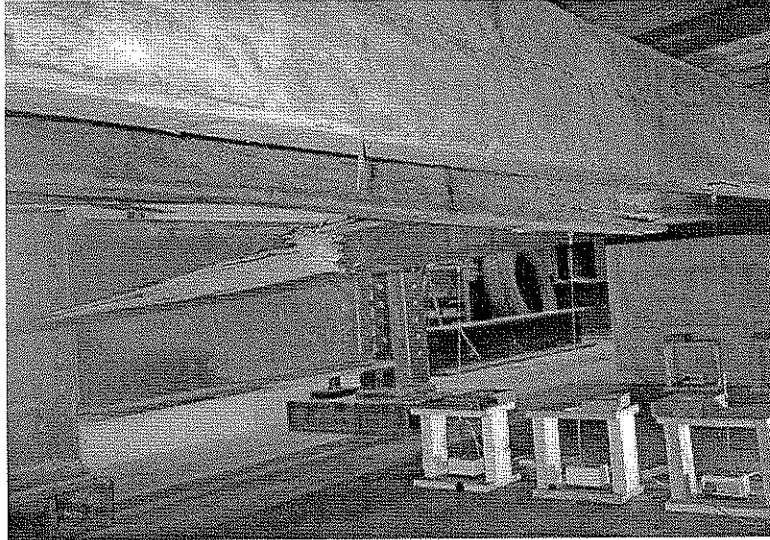
Figure 23. Stringers 1N, 2M and 3S (from right to left) after bridge failure - Bridge 3.

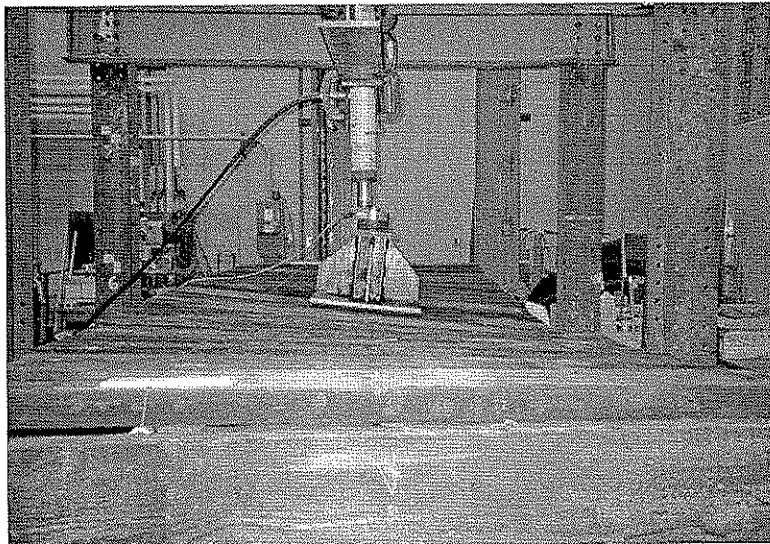
Figure 24. Bridge 3 after failure of stringers (looking east).

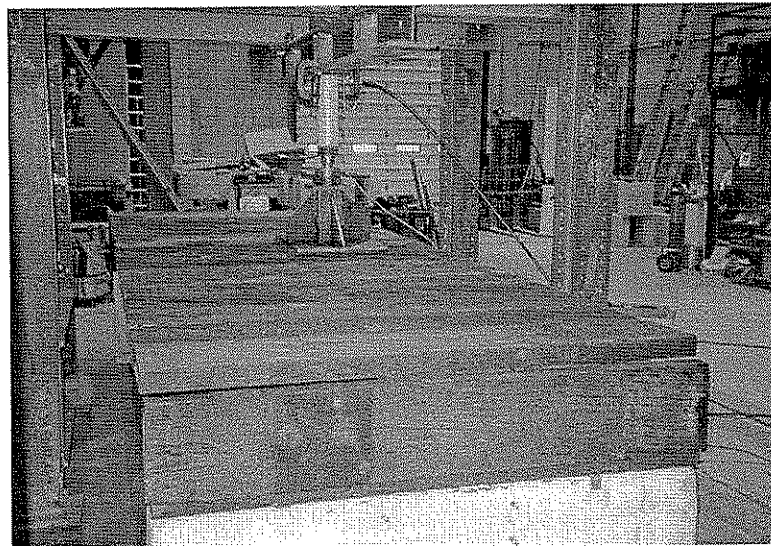
Visual observations prior to testing noted a knot in the tension face (bottom) of stringer 1N near mid-span, some minor surface splitting of stringer 3S near mid-span, and significant weathering at the inside face of stringer 1N.

Figure 26. Bridge 4 prior to testing (looking west).

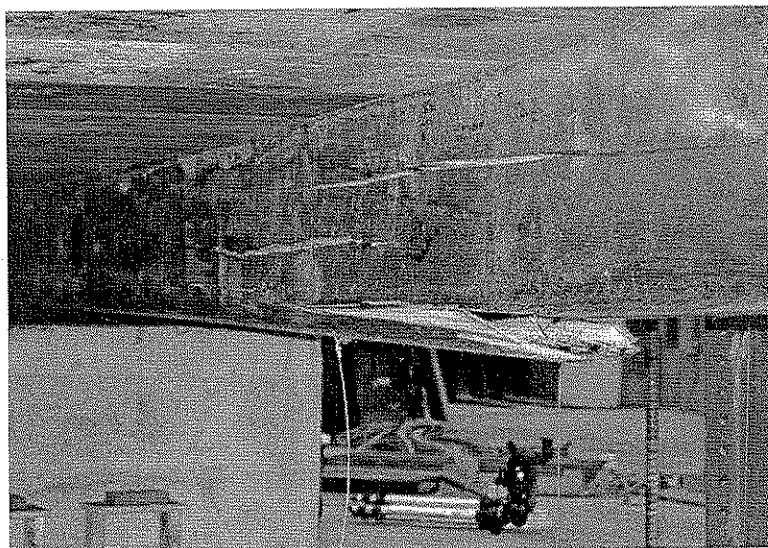
bridge response, stringer 1N exhibited stiffer load/deflection behavior than stringers 2M and 3S (this statement is based on all three stringers carrying an equal percentage of the applied load). At about 17,000 lbs. (75.6 kN), the slope/deflection plot of stringer 1N increased, indicating that there was an increase in the load distribution to stringers 2M and 3S. At 27,000 lbs. (120.1 kN), the slopes of the load/deflection plot became nonlinear. At 34,000 lbs. (151.2 kN), it was observed visually that a crack formed in stringer 3S. The ultimate load was 36,300 lbs. (161.5 kN) with stringer 3S developing a major flexural crack and some major horizontal cracking (see Figure 28). Some cracking also occurred in stringer 2M at mid-span. Inspection of stringer 1N showed that some noticeable cracking was beginning to develop near the knot in the tension fibers, evident by the splitting of the wood around the knot. The final condition of Bridge 4 after the failure is seen in Figure 29. None of the deck planks were damaged. Failure of the bridge was sudden and was characterized by flexural failure of the stringers.

Figure 28. Stringer 3S failure - Bridge 4.

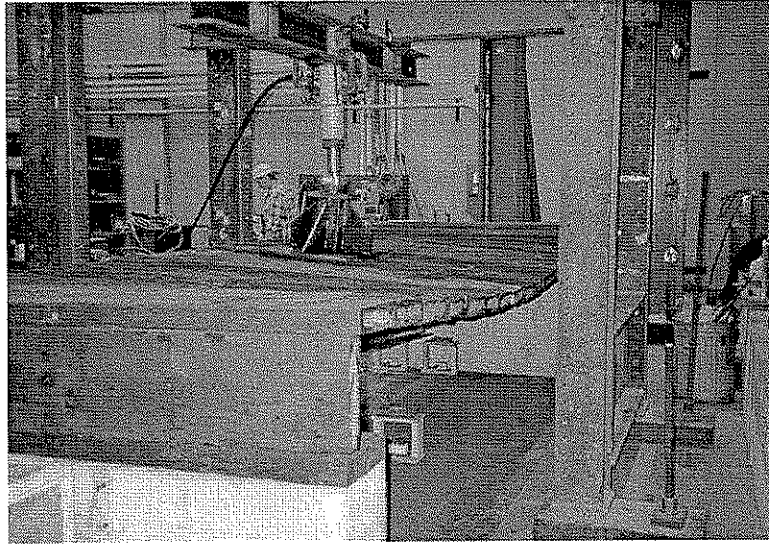
Figure 29. Bridge 4 after failure of stringers (looking east).
